**Louisiana's *Bousillage* Tradition:
Investigation of Past Techniques
for Future Practice**

FITCH MID-CAREER GRANT FINAL REPORT

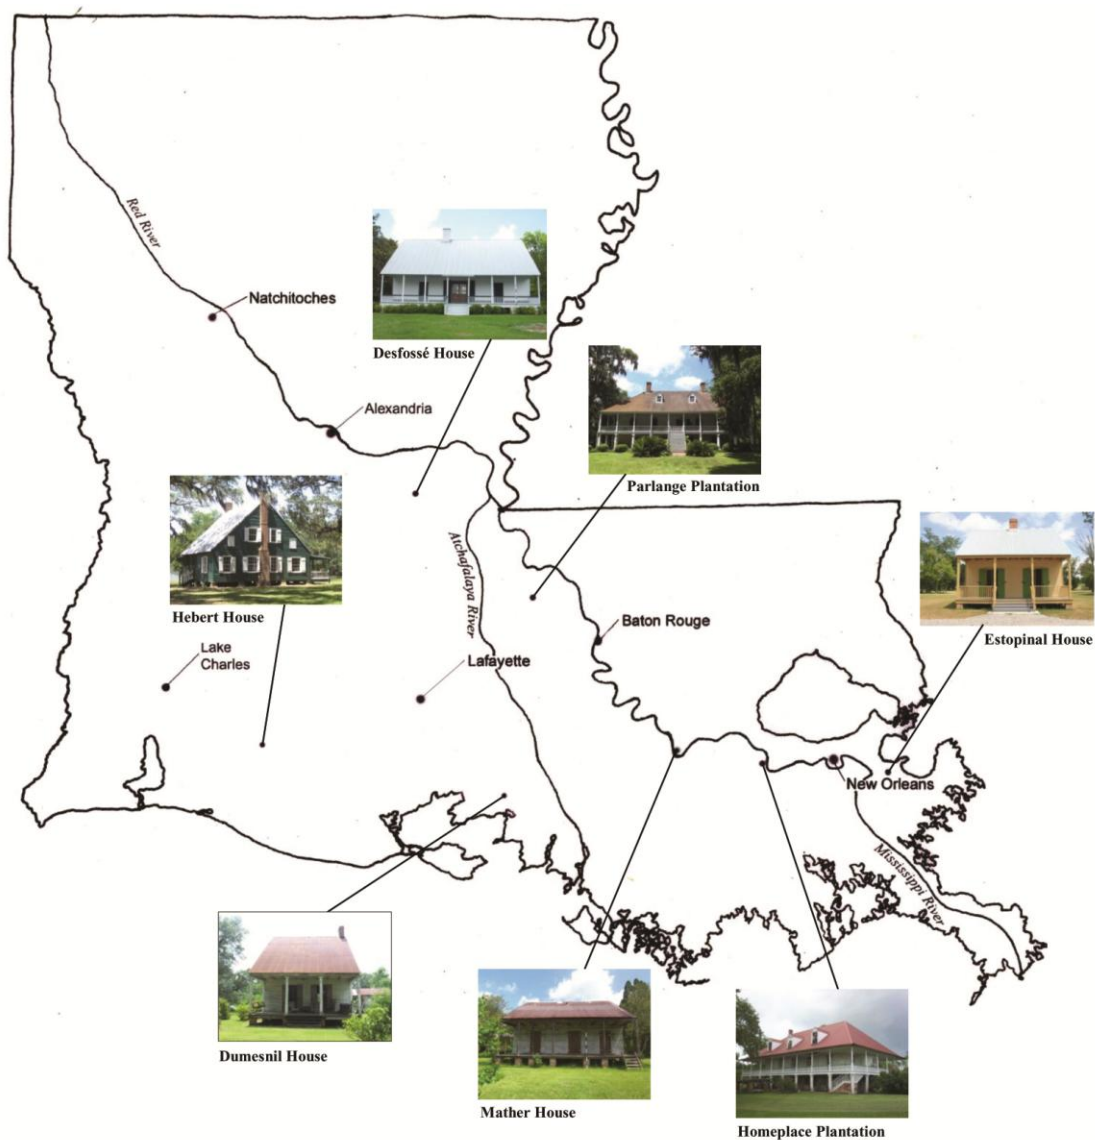
Fig. 1: Map of primary buildings discussed in this report, by L. Blokker. Photograph of Hebert House by H. Knight, 2011. Photograph of Estopinal House by L. Blokker, 2011. Photographs of sample collection sites, Parlange Plantation, Homeplace Plantation, Mather House, Dumesnil House, and Desfossé House, by L. Blokker, 2008, with the funding support of an Old Salem Architectural Fellowship.

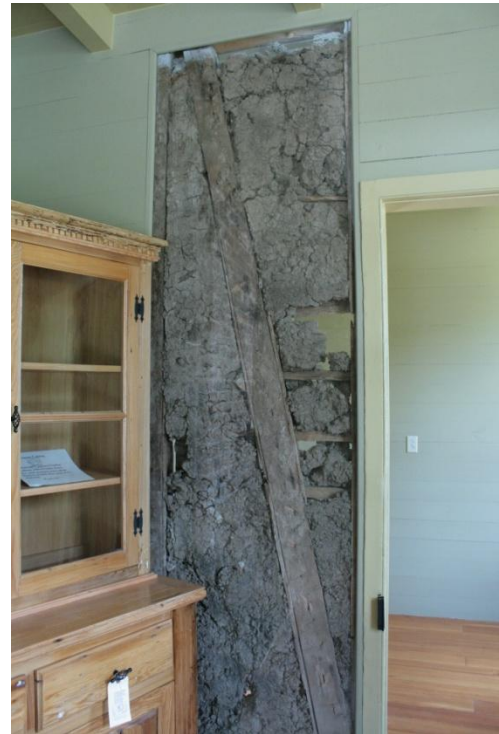
The clay of the *bousillage* is of a light color typical of this southeastern area and it is mixed with a well-integrated abundance of moss. The moss appears to be cured. The work in situ demonstrates yet another variation in the post and *barreaux* arrangement that the researchers had not encountered in some forty buildings examined previously. In the Estopinal House, the *barreaux* are almost completely horizontal, which is not uncommon, but along the posts and braces on either side of the *barreaux* are attached thin strips of wood. The intention of this

Fig. 2 (above): Preserved section of *bousillage* in Estopinal House. Fig. 3 (below): Close-up of *bousillage* section showing thin strips of wood affixed to brace, indicated by arrows. Photographs by L. Blokker.

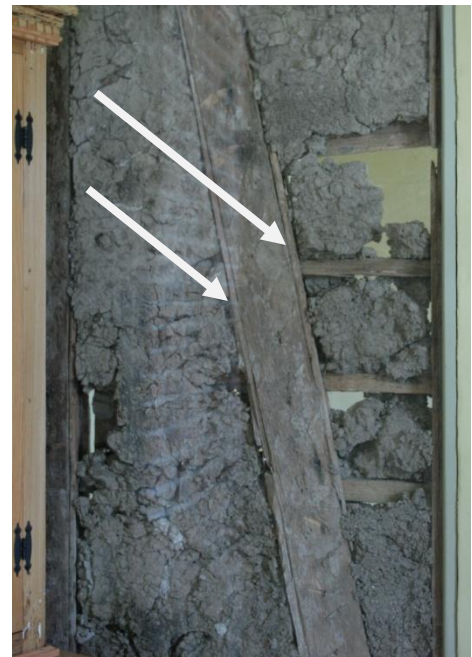
detail is uncertain, but it is possible that it was meant as extra reinforcement to keep the *barreaux* and the nogging from being able to move out of the wall. If so, it could represent an evolution of a practice in which a concave trough was hewn out of the sides of the posts and braces. This is known to have been done in Missouri where the method may have derived from the infill technique of *pierrotage* (stones and mortar) which uses no *barreaux* and would therefore require another device to keep the nogging in place.¹ The authors have not documented any example like this in Louisiana, but interviewee, Wade Lege described seeing just such a detail in an eighteenth century house near Baton Rouge. Very similar nailed strips appear in a photograph of a house with a nogging of thick riven oak slats daubed with mud and straw in Riverdale, New Jersey which appeared in a 1980 issue of the *APT Bulletin*.² According to the author of the query that accompanied the photograph, these strips served to hold the oak slats in place. As the slats in this design appear to be stacked one atop another, it is assumed that there would have been no pockets holding their ends. The query author had no information about this infill technique or even a name for it.

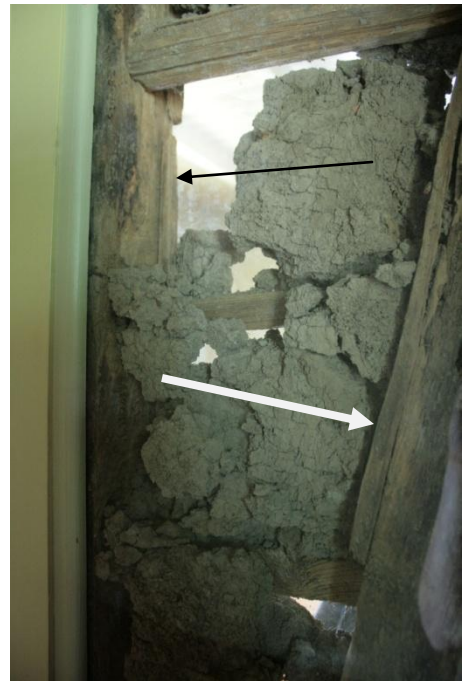
Fig. 4: Detail of *bousillage* with arrows indicating thin wood strips. Photograph by L. Blokker.

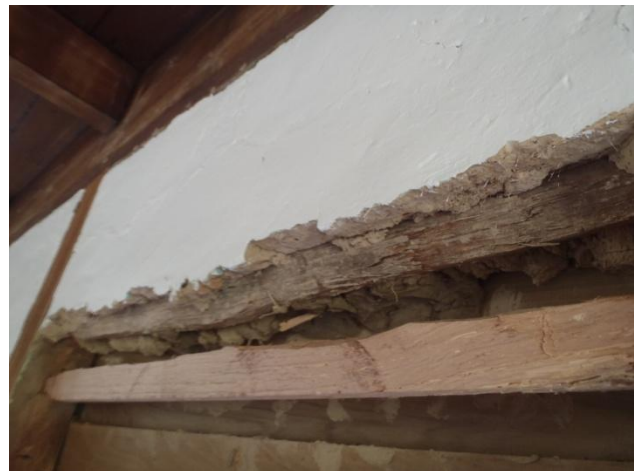
The *bousillage* restoration is being undertaken by Dale Pierrottie of Lafayette. Pierrottie has over twenty years of experience in recreating *bousillage*. This will be discussed in the oral history section of the report. As a portion of the east wall was open, Knight was able to observe both original and reconstructed *barreaux* and *bousillage*. The original *barreaux* are hand-split and tapered at the ends. At 2' - 10", they are the longest *barreaux* the authors have documented anywhere. The newly constructed *barreaux* are machine sawn and uniform in appearance. They are much thinner than the original with one end tapered.

Fig. 5: Detail of original Hebert House *bousillage* and *barreau* above new *barreau*. Photograph by H. Knight.

The original *bousillage* is light brown to pale yellow with what appears to be uncured Spanish moss. The Spanish moss is generous in portion in the salvaged original samples stored on the rear gallery. The nogging sample is more than two inches thick and finished with a lime plaster that has been painted with an inappropriate white latex paint. The plaster is flush with the framing and finished with a chair rail. This evidence accompanied with the fact that the timbers were hand-planed smooth means the timbers were purposely left exposed.

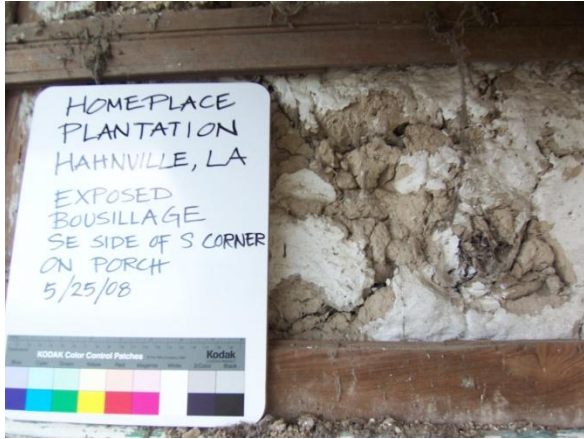
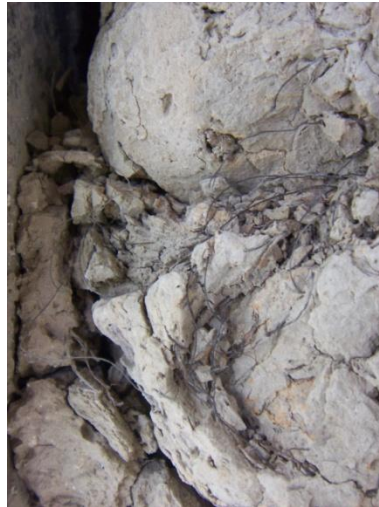
Figs. 6 & 7 (left): *Bousillage* in situ at Homeplace Plantation. Photographs by L. Blokker, 2008, with the funding support of an Old Salem Architectural Fellowship.

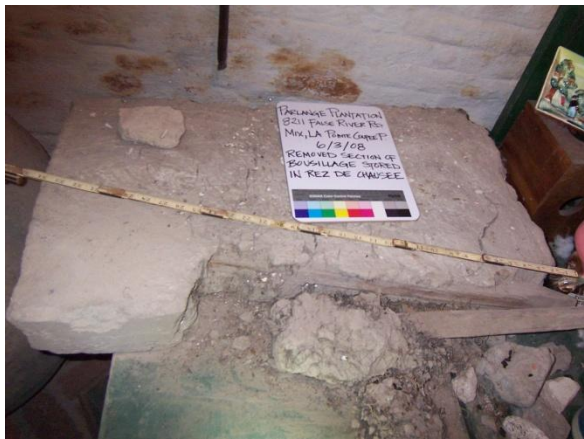
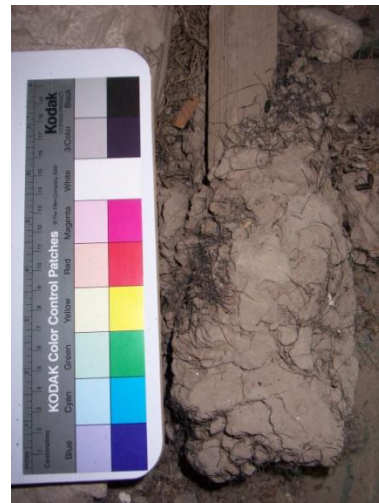
Figs. 8 & 9 (left): Loose *bousillage* at Parlange Plantation. Photographs by L. Blokker, 2008, with the funding support of an Old Salem Architectural Fellowship.

The Desfossé sample was found to have a remarkably similar mineralogy to the Dumesnil sample, and likewise, the Parlange sample to the Mather sample. Although these sites are geographically dispersed, they may share a common geological development. Mather is located on the Mississippi River and Parlange, while not on the Mississippi, sits on the False River, a former part of the Mississippi that is now an oxbow lake. Meanwhile Desfossé and

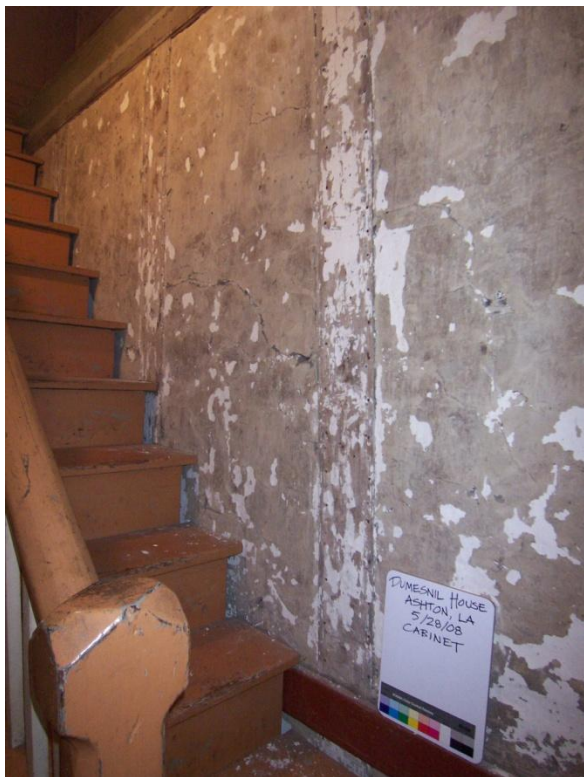
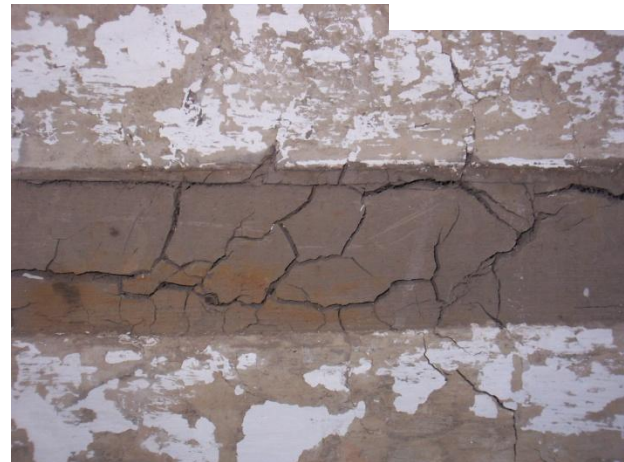
Figs. 10 & 11 (left and above): Interior *bousillage* wall at Dumesnil House and detail of cracked *bousillage* revealed by removal of chair rail. Photographs by L. Blokker, 2008, with the funding support of an Old Salem Architectural Fellowship.

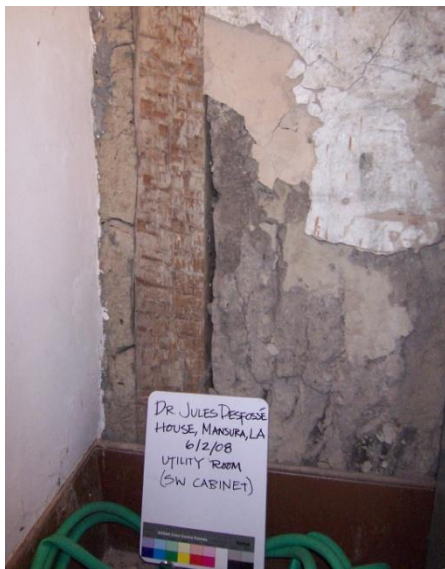
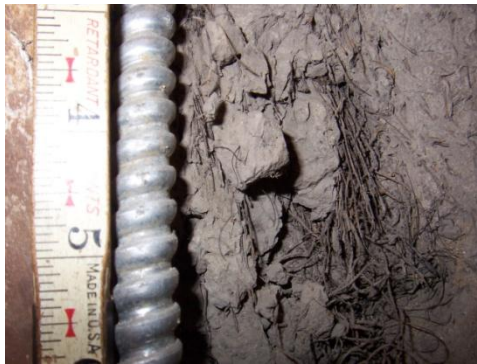
Figs. 12 & 13 (left): *Bousillage* in situ at the Desfossé House. Photographs by L. Blokker, 2008, with the funding support of an Old Salem Architectural Fellowship.

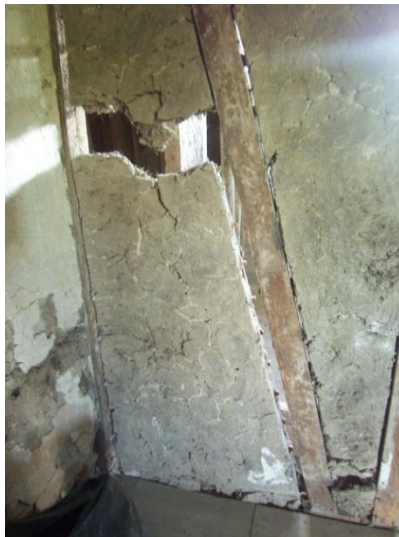
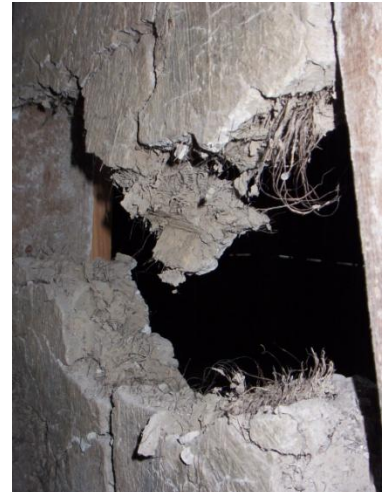
Figs. 14 & 15 (right): *Bousillage* in situ at Mather House. Photographs by L. Blokker, 2008, with the funding support of an Old Salem Architectural Fellowship.
